# Manhole Inspection Summary

Manhole # S39YY\_014MH

Insp Date: **12/15/06 1:37 PM**

**Location** Address: **3224 AVON AVE**

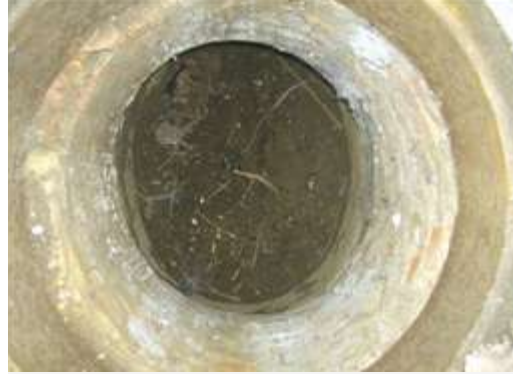
Top View

Channel debris.

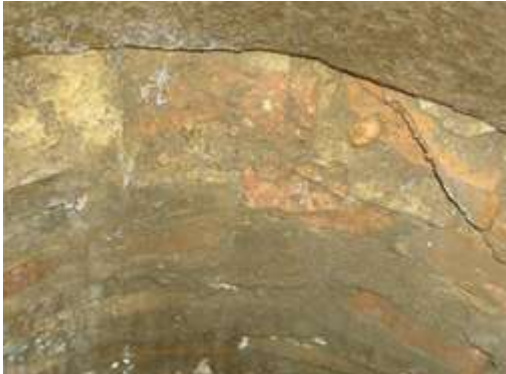
Defect

Frame leaks. Frame offset. Adjustment deterioration and infiltration.

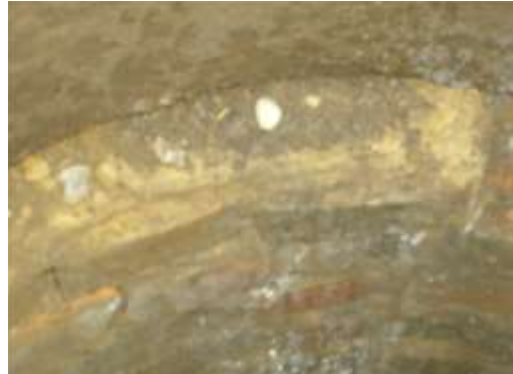
Defect

Frame leaks. Frame offset. Adjustment infiltration.

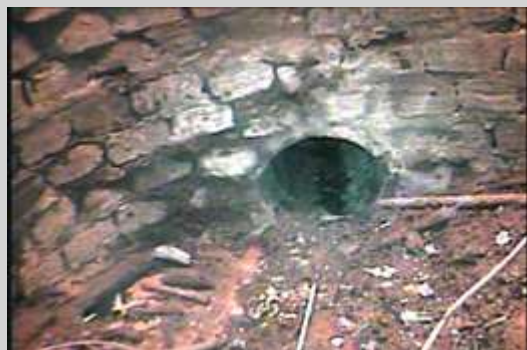
Barrel deterioration and infiltration.
